Requirements validation testing on the 7 optical fiber array connector/cable assemblies for the Lunar Reconnaissance Orbiter (LRO)

Melanie N. Ott^{a*}, Xiaodan "Linda" Jin^b, Frank V. LaRocca^c, Adam Matuszeski^a Richard F. Chuska^c, Shawn L. MacMurphy^c

NASA Goddard Space Flight Center, Greenbelt Maryland 20771
 Perot Systems Government Services, Fairfax, VA 22031
 MEI Technologies, Seabrook Maryland 20706

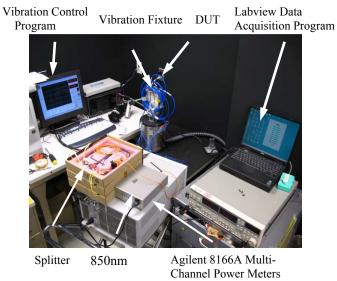
Figure 3: Random Vibration Testing Set up For the Laser Ranging Optical Fiber Assemblies

At the input an 850 nm LED was connected to a splitter so that it could be injected into the seven fiber array assembly set with one channel of the splitter connected to the detector. The optical source is monitored for power transients such that those variations can be subtracted from the end result test data. The reference fan out assemblies used here have on one side an array optical fiber connector and on the other side seven individual FC optical fiber connectors. These fan out assemblies that take individual channels and couple them into the array set (and vice versa) are used on the input and output sides of the set up. The individual channels are monitored with the HP8166 multi-channel optical power multimeter and logged to a data file using LABVIEW software. Even though all channels were monitored the data is presented as an average for the bundle since no single channel cracked or increased insertion loss beyond acceptable limits.

The three profile test program was designed to simulate all the vibration exposure opportunities that would occur from system level integration through launch. During testing the cable assembly set is monitored in-situ at 850 nm to eliminate system noise from the test results and to monitor for any damage as it occurs. The other before and after testing is performed at 532 nm on a separate test set up and does include noise related to changing testing set ups and end faces are inspected post testing to ensure no cracking of the fiber had occurred. Figure 3 is a picture of the testing set up with in-situ monitoring.

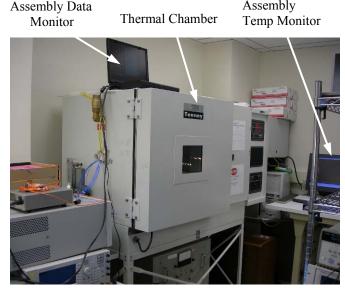
Figure 4: Thermal Cycling Testing Set-Up for the Laser Ranging Optical Fiber Bundle Array Assemblies

For this test, the thermal range was -55°C to +80°C, for 100 cycles, at 2°C/min and 30 minute dwells at the extremes. The reference fan out assemblies were used again to couple light in and out of the LR test sets. The interconnection of both fan out arrays to the test sets were placed inside the thermal chamber so that all interfaces were exposed to the thermal extremes. Therefore, instead of open beams at either ends of the assemblies there were two connections to other array assemblies. This of course would potentially over estimate the losses over the thermal range. For registering the relative insertion losses at 850 nm the HP8166 was used and for registering the data at 532 nm the Newport 2930C and an HP8153 with a visible detection module were used. Again the source was monitored and that left three channels for monitoring thermal induced relative insertion loss. One of the outer channels was chosen for monitoring on each assembly set. On Set 1, channel 6 was monitored and on Set 2, channel 2 and 6. During testing the thermal data was captured to compare to the registered losses over temperature. As expect the losses rose as the temperature dropped. After the thermal cycling testing for 100 cycles was complete, one set was removed from the test set up and measured while the other was tested for an additional 10 cycles but this time using a profile of -70°C to +85°C, 2°C/min ramp rate and 30 min dwell at 85°C and 60 min dwell at -70°C.

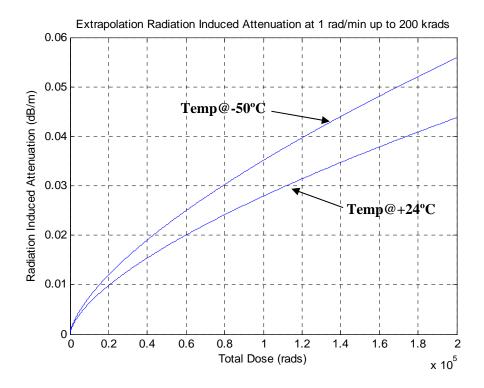
Figure 5: Extrapolation Curve at the dose rate of 1 rad/min up to 200 Krads at temperature of 24°C & -50°C

To scale the units to dB/m, A(D)/L with L equal to 9.5 m which is the actual length of the cables under test, Figure 5 shows the extrapolation curve given a dose rate of 1 rad/min, up to a total dose of 200 Krads for room temperature of 24°C and for -50°C.

To compare the difference that lowering the temperature makes to the extrapolation results, if we use -50°C to calculate the radiation induced attenuation at 200 Krads, the result is 0.056 dB/m. For the same conditions using the graph in Figure 5 the radiation induced loss at 200 Krads and 24°C is slightly lower at 0.044 dB/m as can be seen in Figure 5. This extrapolation model allowed us to set realistic allocations for the radiation induced loss over a range of worst case cold temperatures and shielding conditions across the LRO space craft. The bundle materials that surround the flexlite cable in the actual application do provide some shielding but does not significantly affect the radiation induced attention.
